Empire Offshore Wind LLC

Empire Wind 1 Project
Article VII Application

Appendix E
Benthic Resource Characterization Reports

June 2021

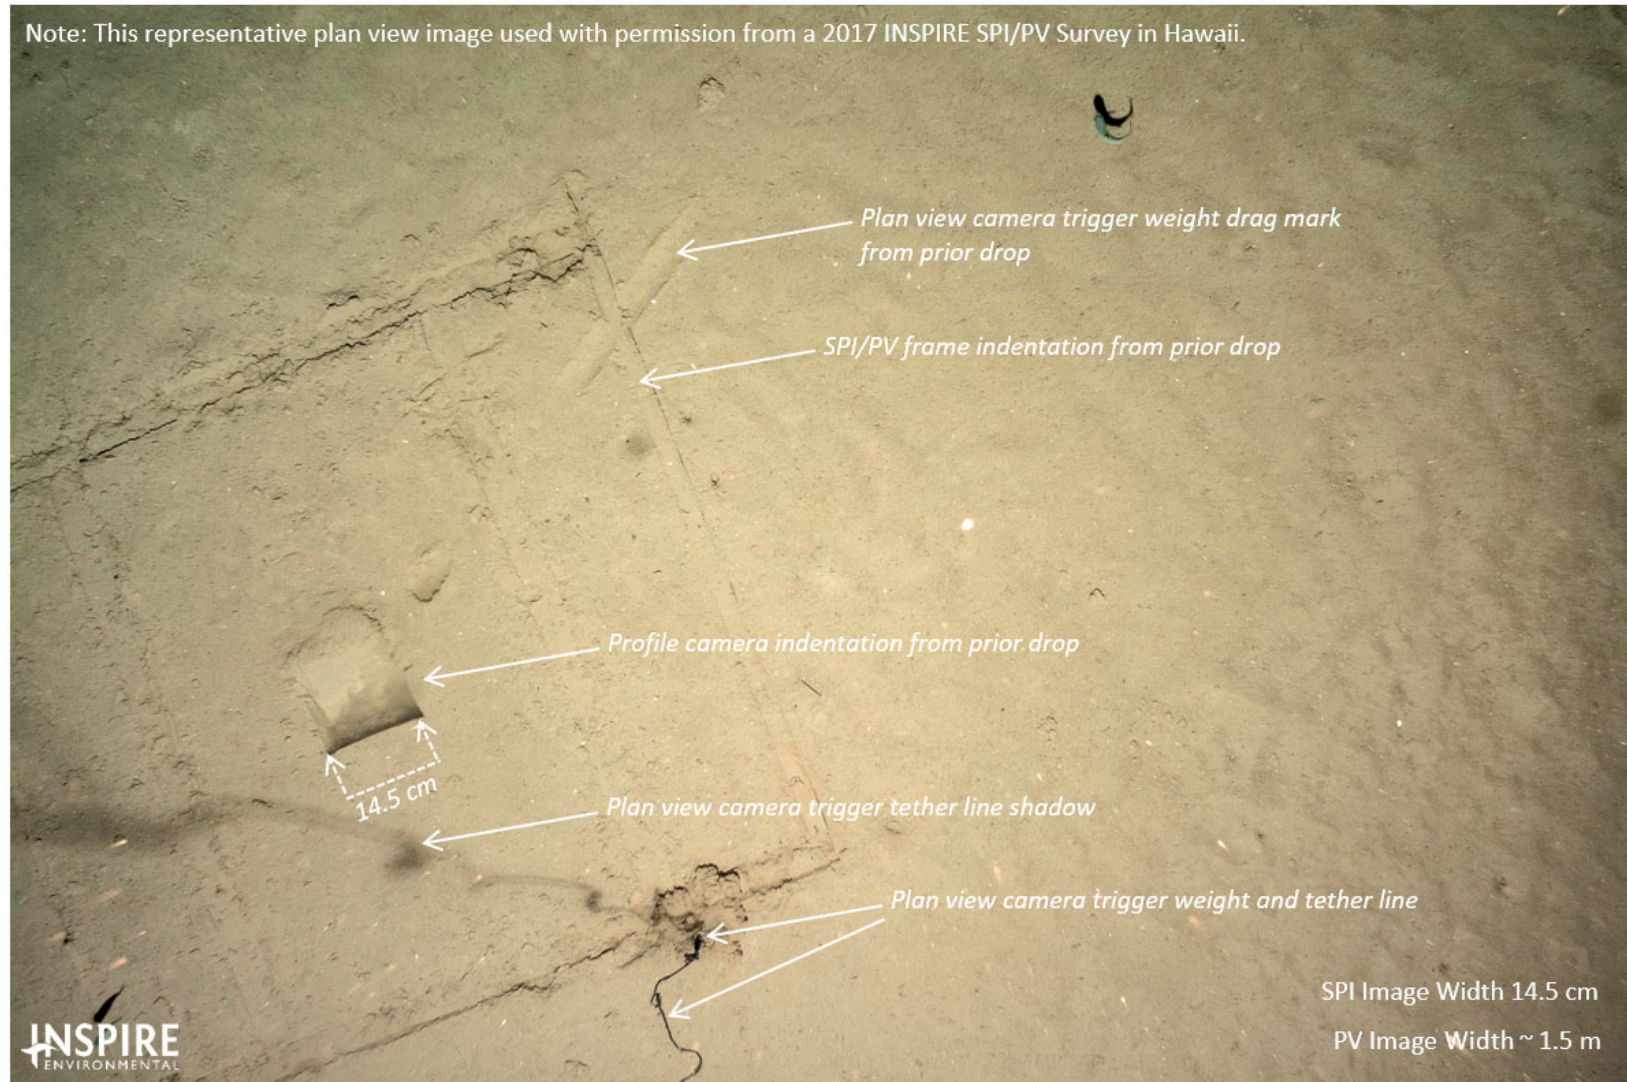
Figure 2-6. *This representative plan view image shows the sampling relationship between plan view and sediment profile images. Note: plan view images differ between surveys and stations and the area covered by each plan view image may vary slightly between images and stations.*

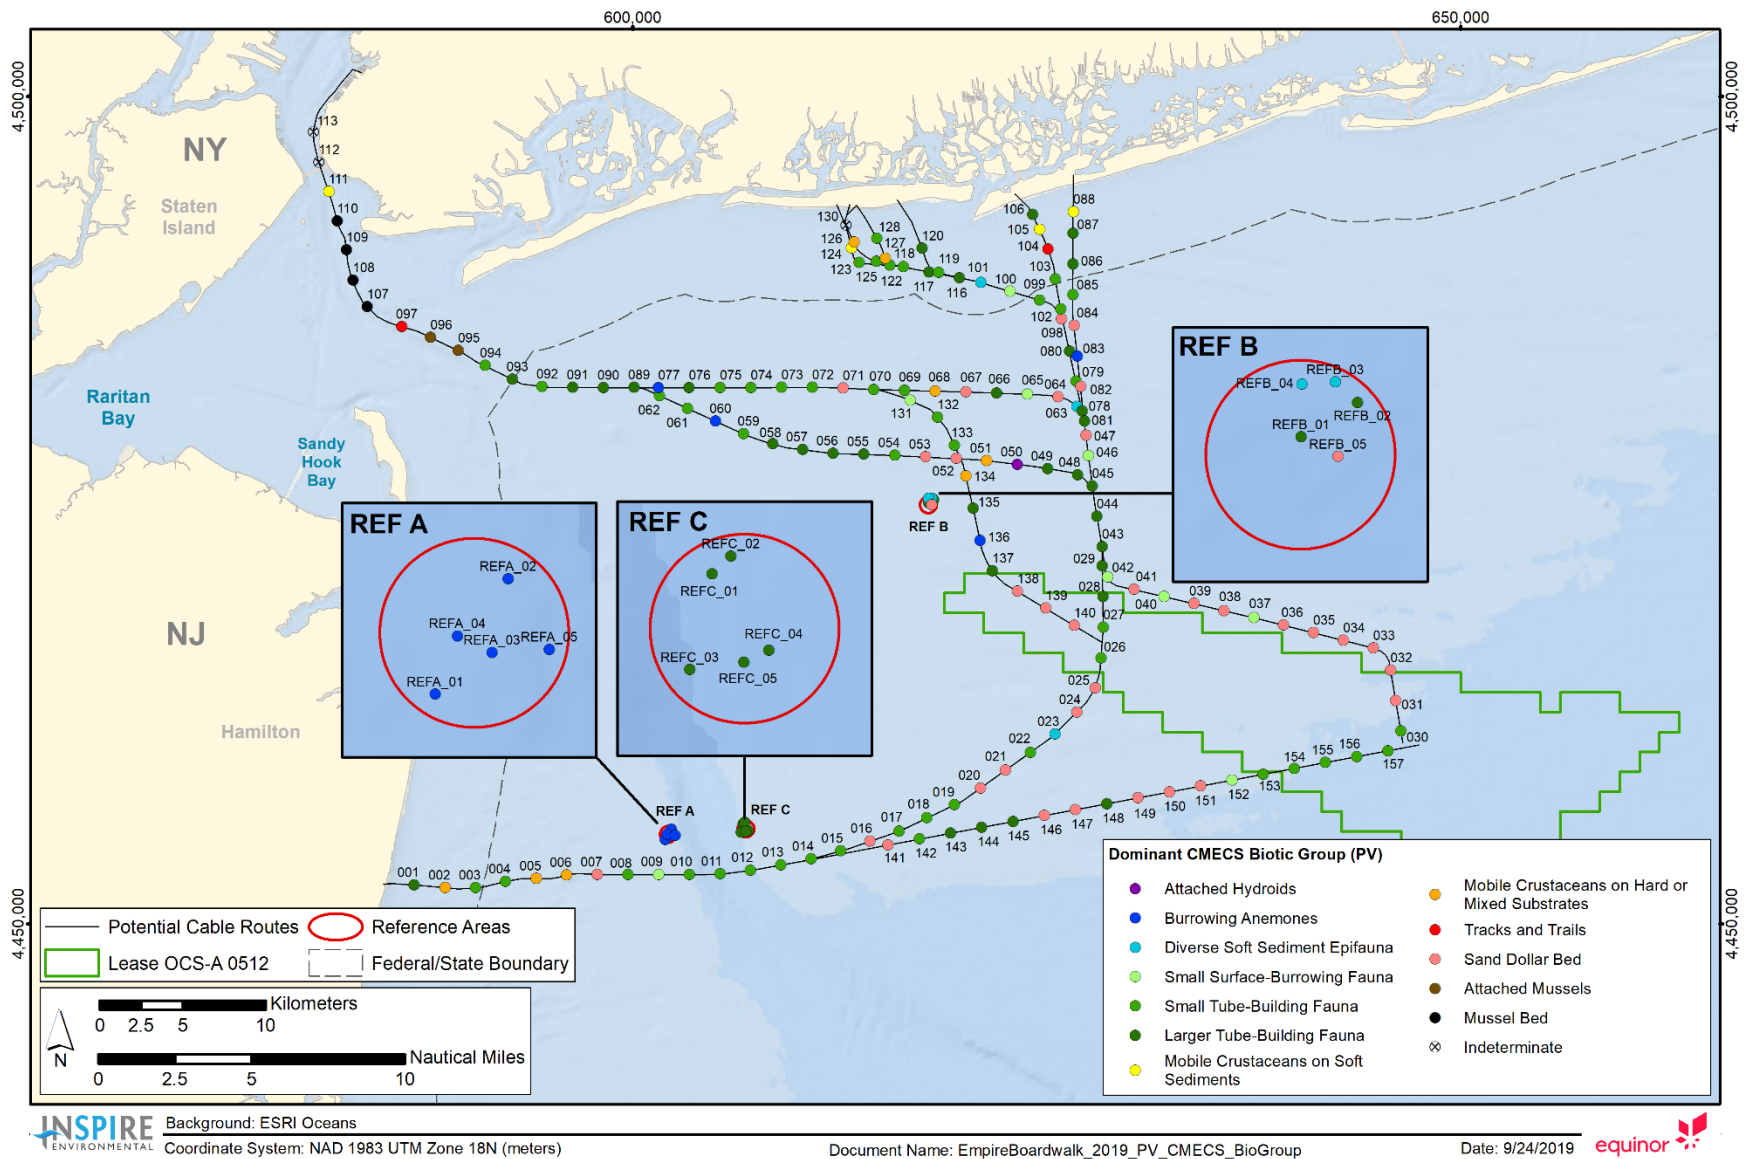
Figure 3-22. Dominant CMECS Biotic Group at the Equinor Wind survey area

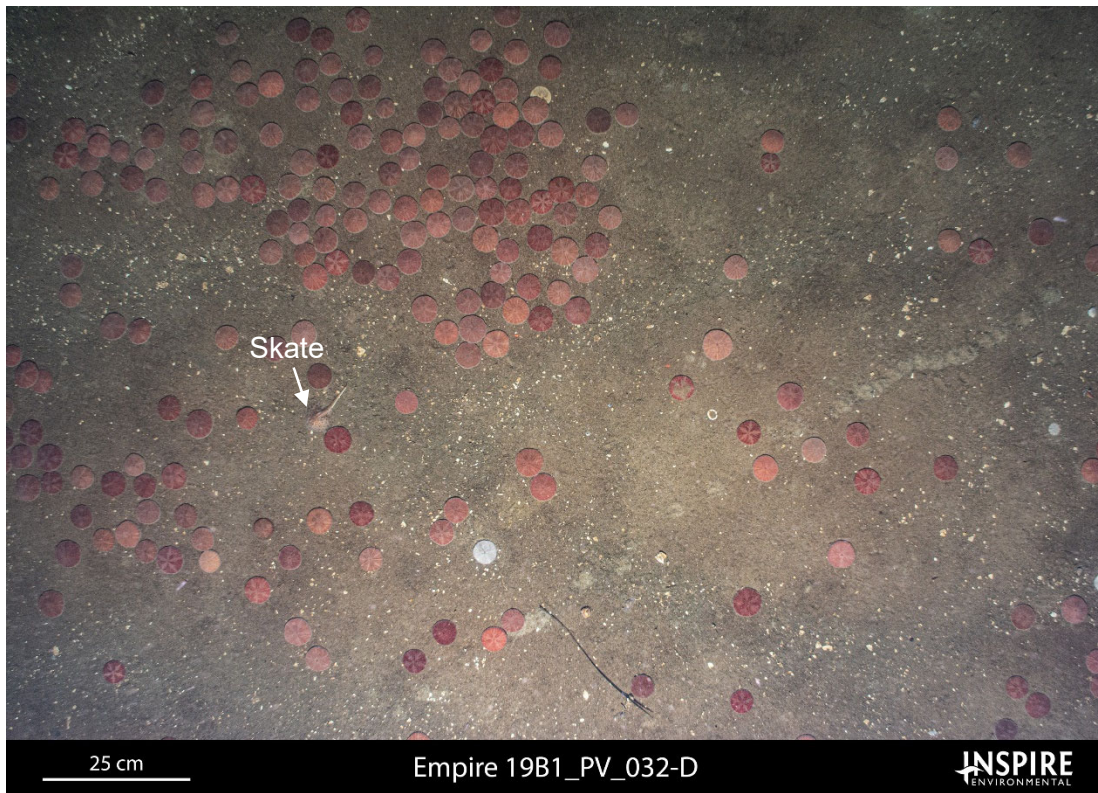
Figure 3-45. Plan view images at Stations 032 and 033 where skate were observed. At Station 033 the skate was observed partially buried in the seafloor.

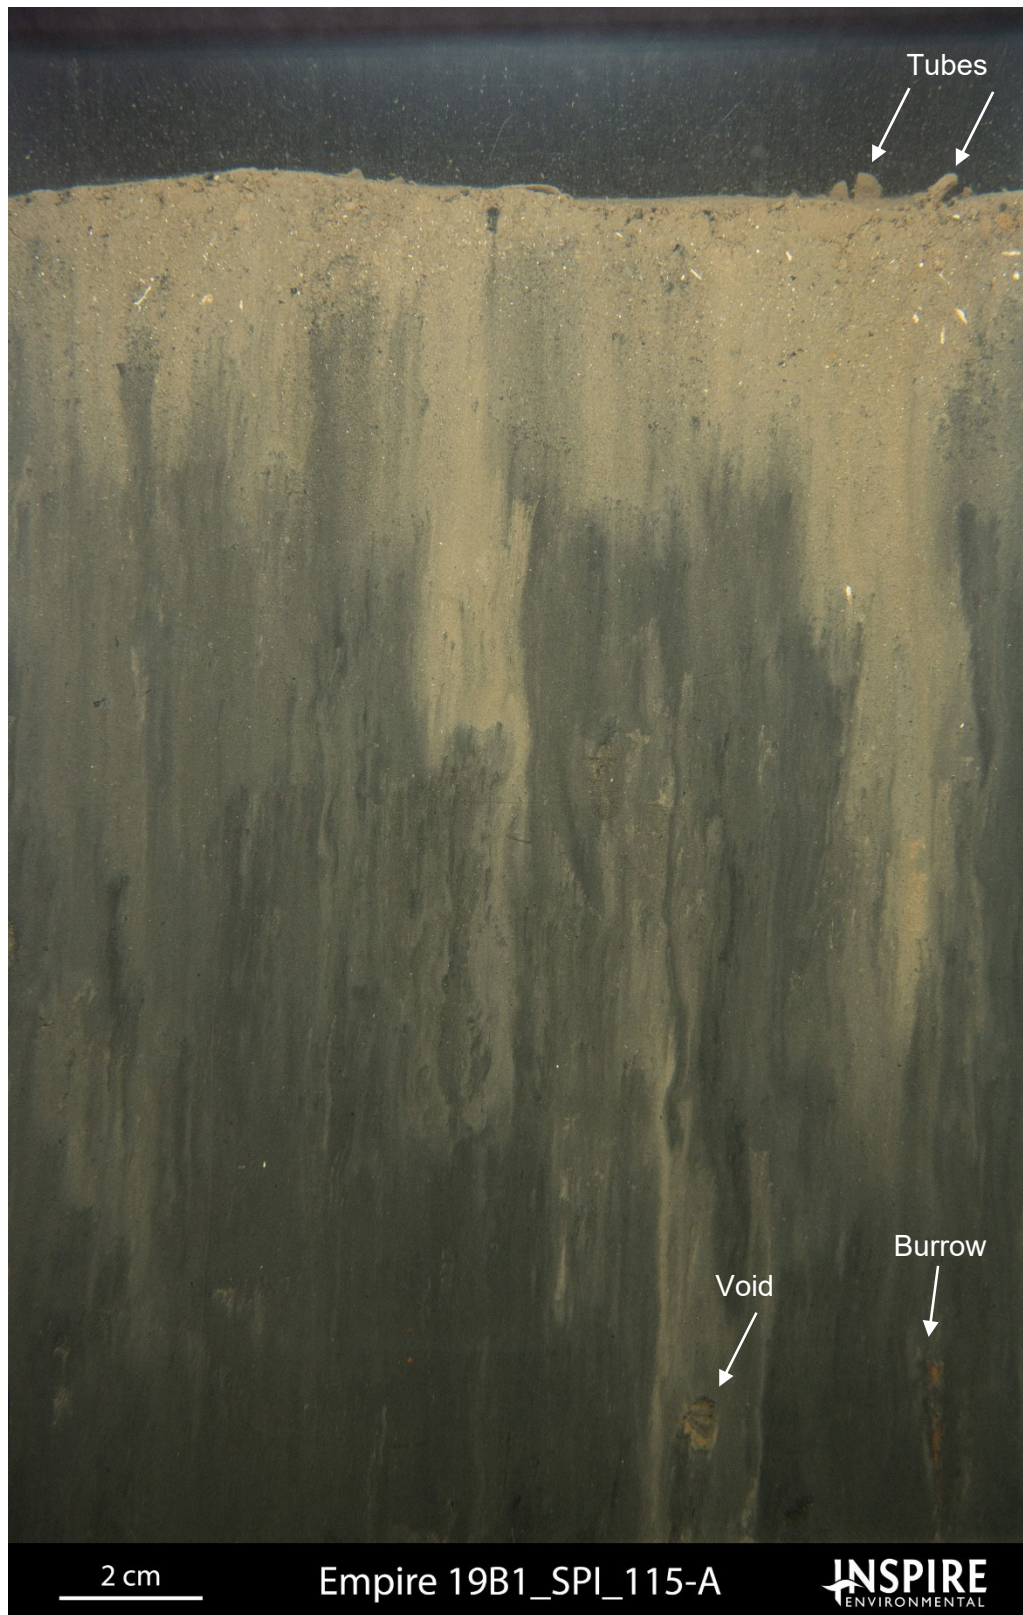
Figure 3-56. Profile image of Station 115 composed of silt-clay with deep prism penetration and the presence of feeding voids, deep burrowing fauna, and tubes on the sediment surface

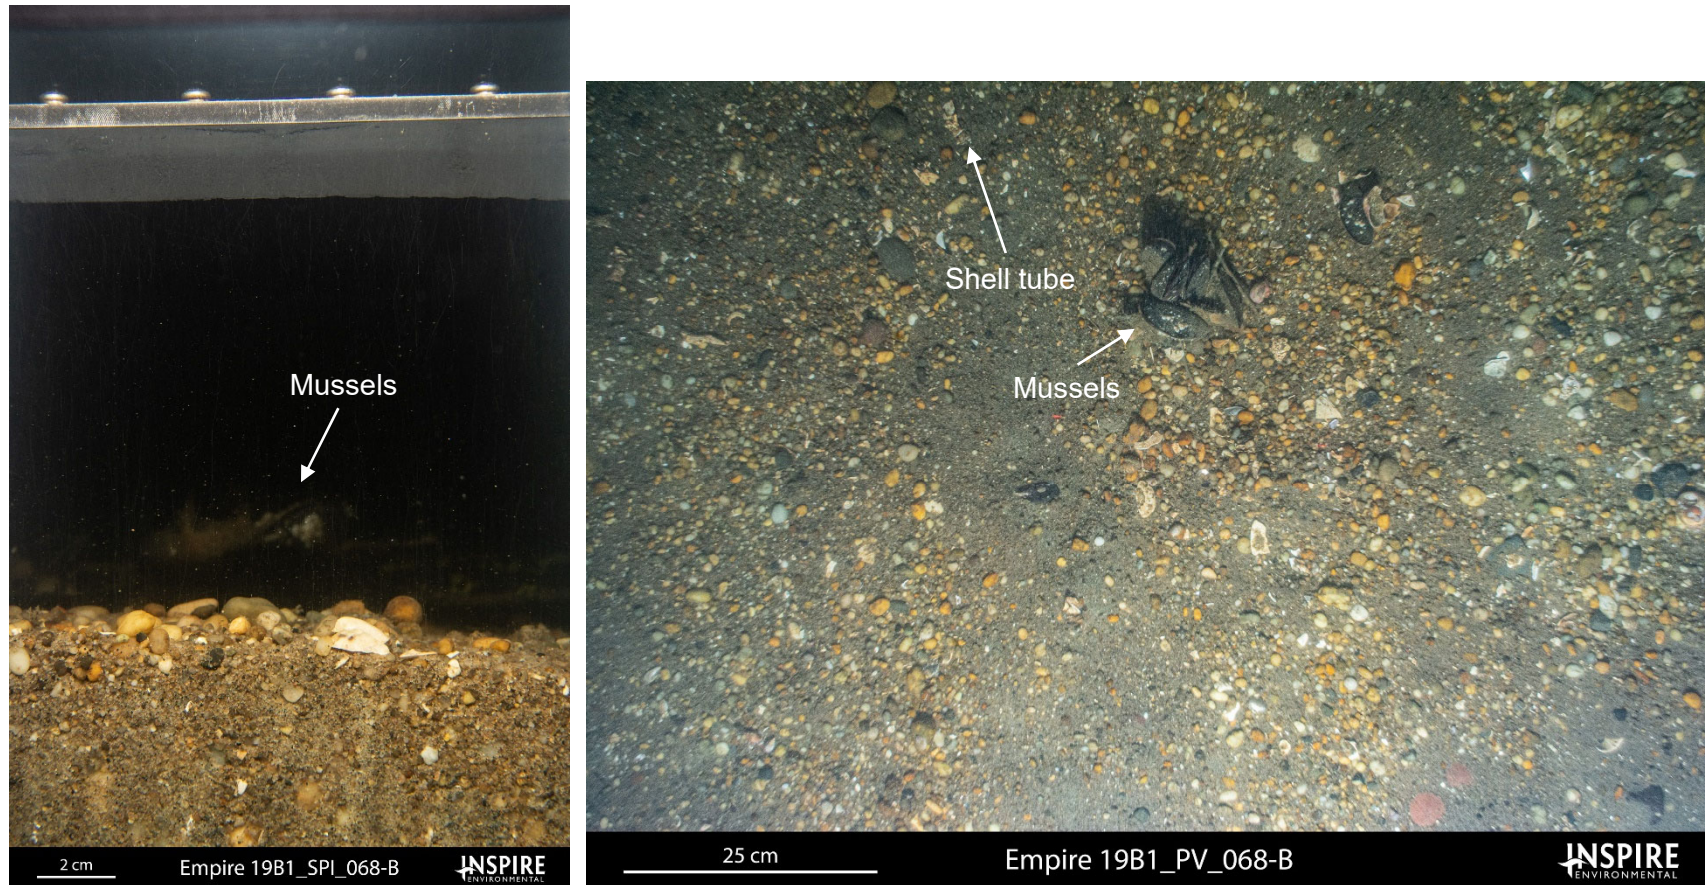
Figure 3-57. Profile and plan view images at Station 068 with mussels present on the seafloor along with tube building fauna (mussels visible in the background of the profile image). The sediment oxygen demand is low and the aRPD extends beneath the prism penetration.

The predominant CMECS Biotic Subclass along the NYHECR was Soft Sediment Fauna (Table 3-3b; Figure 3-15) with most station designated with this Biotic Subclass. The Attached Fauna Biotic Subclass was found at: Station 050 located on Cholera Bank, which was composed of boulders (Figures 3-4, 3-6E, 3-20B, 3-29); Station 068 where Soft Sediment and Attached Fauna were both designated as the dominant Biotic Subclass due to the presence of mussels along with tube building fauna (Figure 3-57); and Stations 107-110 located in NY state waters,

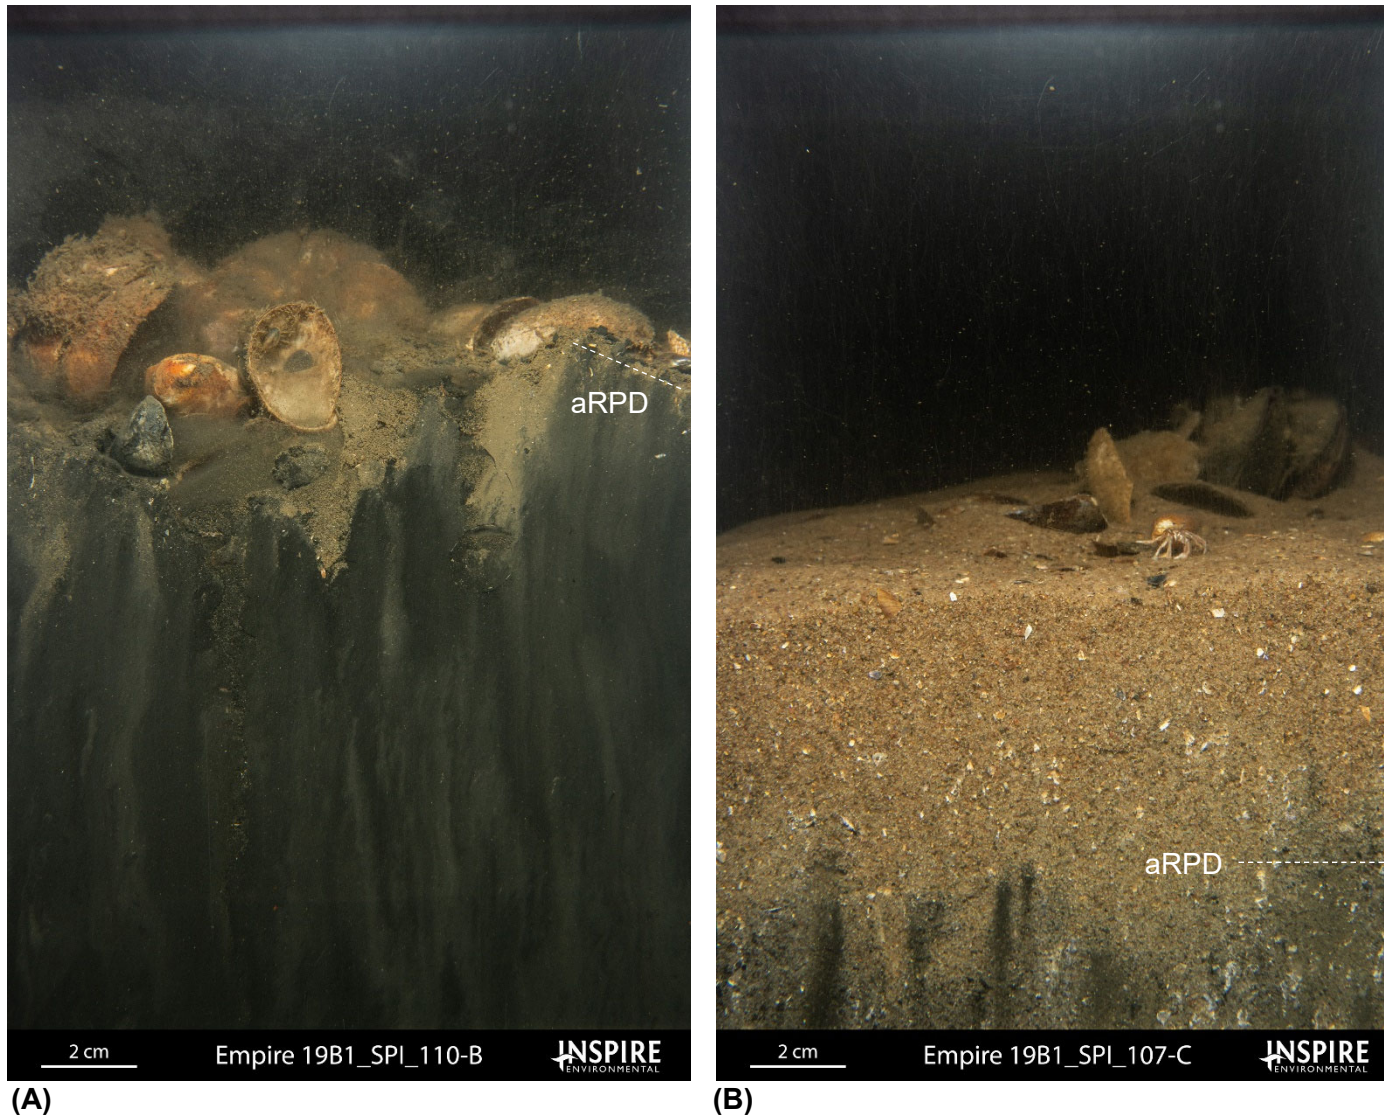
Figure 3-58. Profile images depicting (A) Station 110 with a diffusional aRPD and high sediment oxygen demand (SOD), note oxid brown sediment is dragged down into sediment column; and (B) Station 107 with a deep aRPD and medium SOD. Stations 110 and 107 had the shallowest and deepest aRPDs, respectively, along the New York Harbor Export Cable Route.
